MARLIN-ROCKWELL COMPANY
DIVISION OF TRW INC.

M-R-C RESEARCH PROPOSAL NO. 1540
for
GEORGE C. MARSHALL SPACE FLIGHT CENTER
Huntsville, Alabama

"Spin Axis Bearings"

Report - Phase V
Contract No. NAS 8-5441

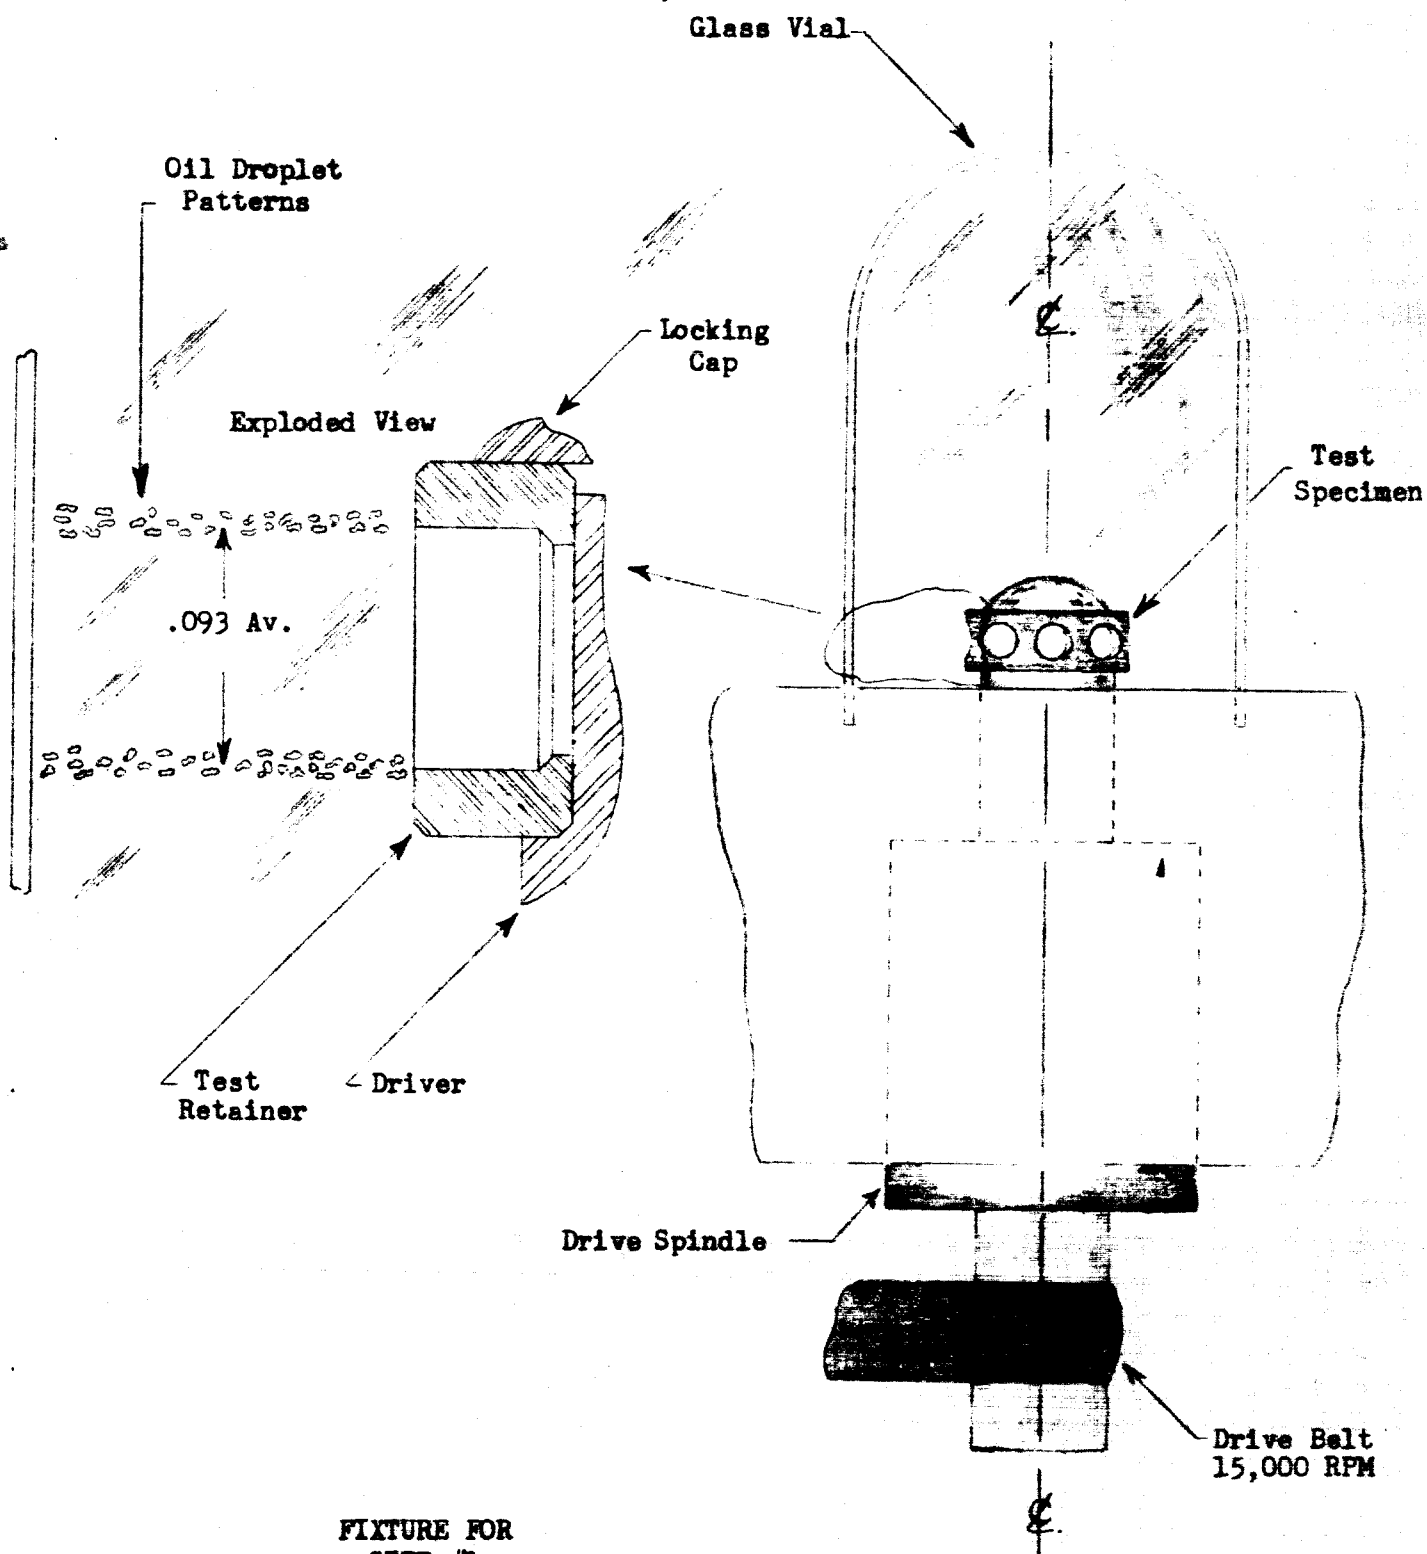
R-52004-E

FIXTURE FOR
STEP #1
RETAINER SCREENING
PROGRAM

5. A clean clear glass vial or bonnet with an I.D. of 23 mm was placed over the retainer to be tested as shown, MRC Dwg. #R-52004-E, page 15. All oil which leaves the retainers during spin tests was collected on the vial I.D. The vials were used to ascertain bleed rates and patterns as described in items 9 and 10.

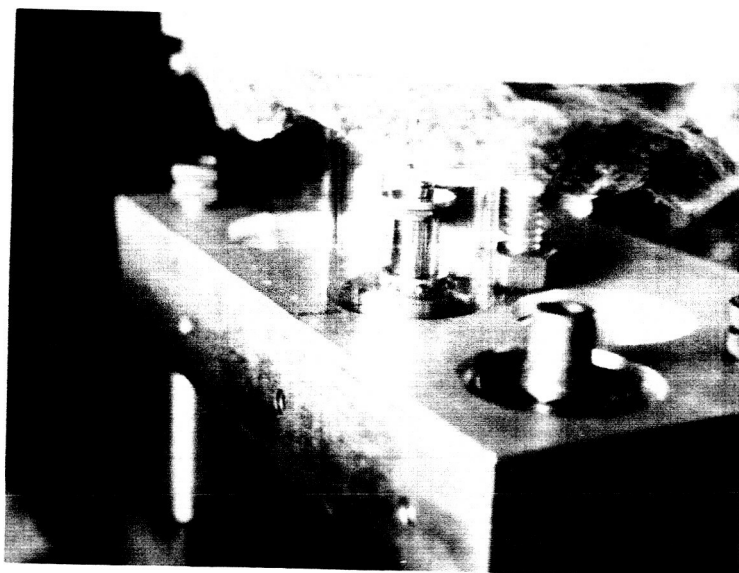
PHOTO NO. 2
Close-Up View of Test Rig Showing Retainer
Assembled in a Bearing, Step #2 Conditions
(Bearing has half of outer removed.)

A test fixture was fabricated which would duplicate as closely as possible the actual running of the retainer in the bearing assembly and still observe the oil bleedout patterns. (See Photo No. 1 showing the whole test rig, and Photo No. 2 showing a close-up of a portion of the rig with a retainer in a bearing assembly.)

The outer ring had been cut in half along the center of the race so that oil bleed out patterns can be monitored more closely.

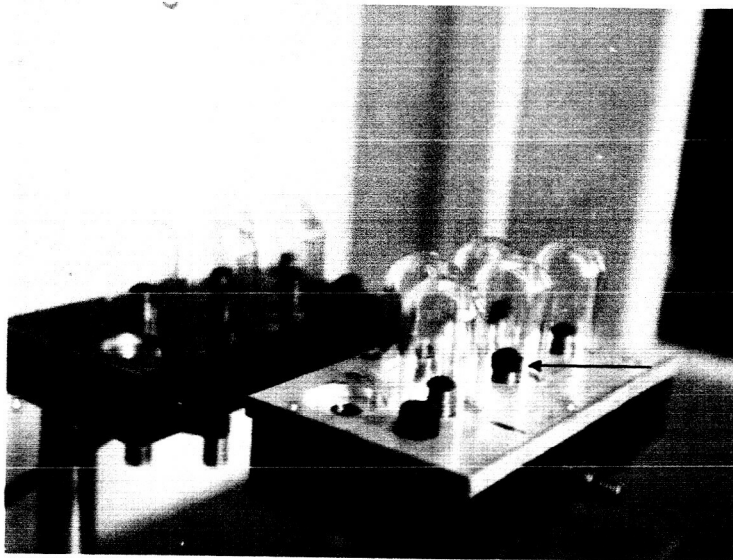
PHOTO NO. 3
Close-Up View of Test Rig Showing Set-Up for
Step #1 Conditions
(Arrow points to retainer)

3. The test rig without retainers was pre-run for 24 hours to stabilize the temperature at 160°F.
4. The test rig was stopped and the test retainer was placed on the arbor.
(See Photo No. 3.) It was secured by lightly tightening the screw on the retainer face. There was a diametrical clearance of .001" between arbor O.D. and retainer I.D.

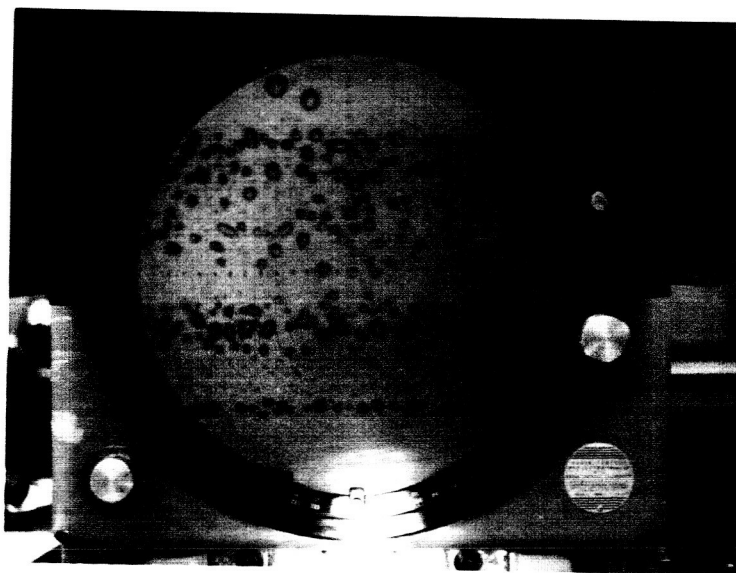
PHOTO NO. 4
Magnified View of Retainer Bleed Out Pattern
(Actual droplet size varies from .003" to .020" diameter.)

7. Visual observations could be made during operation.
8. The fixture was small enough to be placed in a controlled environment.
9. Photographs could be taken of oil bleedout patterns. (See Photo No. 4.)

There were 100 retainers fabricated in 10 lots of 10 specimens each. Only 5 retainers from each lot, however, were tested in Step 1. During the testing in Step 1, Section A, we observed that there were two rows of oil droplets on vial I.D.'s. The distance between these rows was equal to the diameter of the ball pockets.

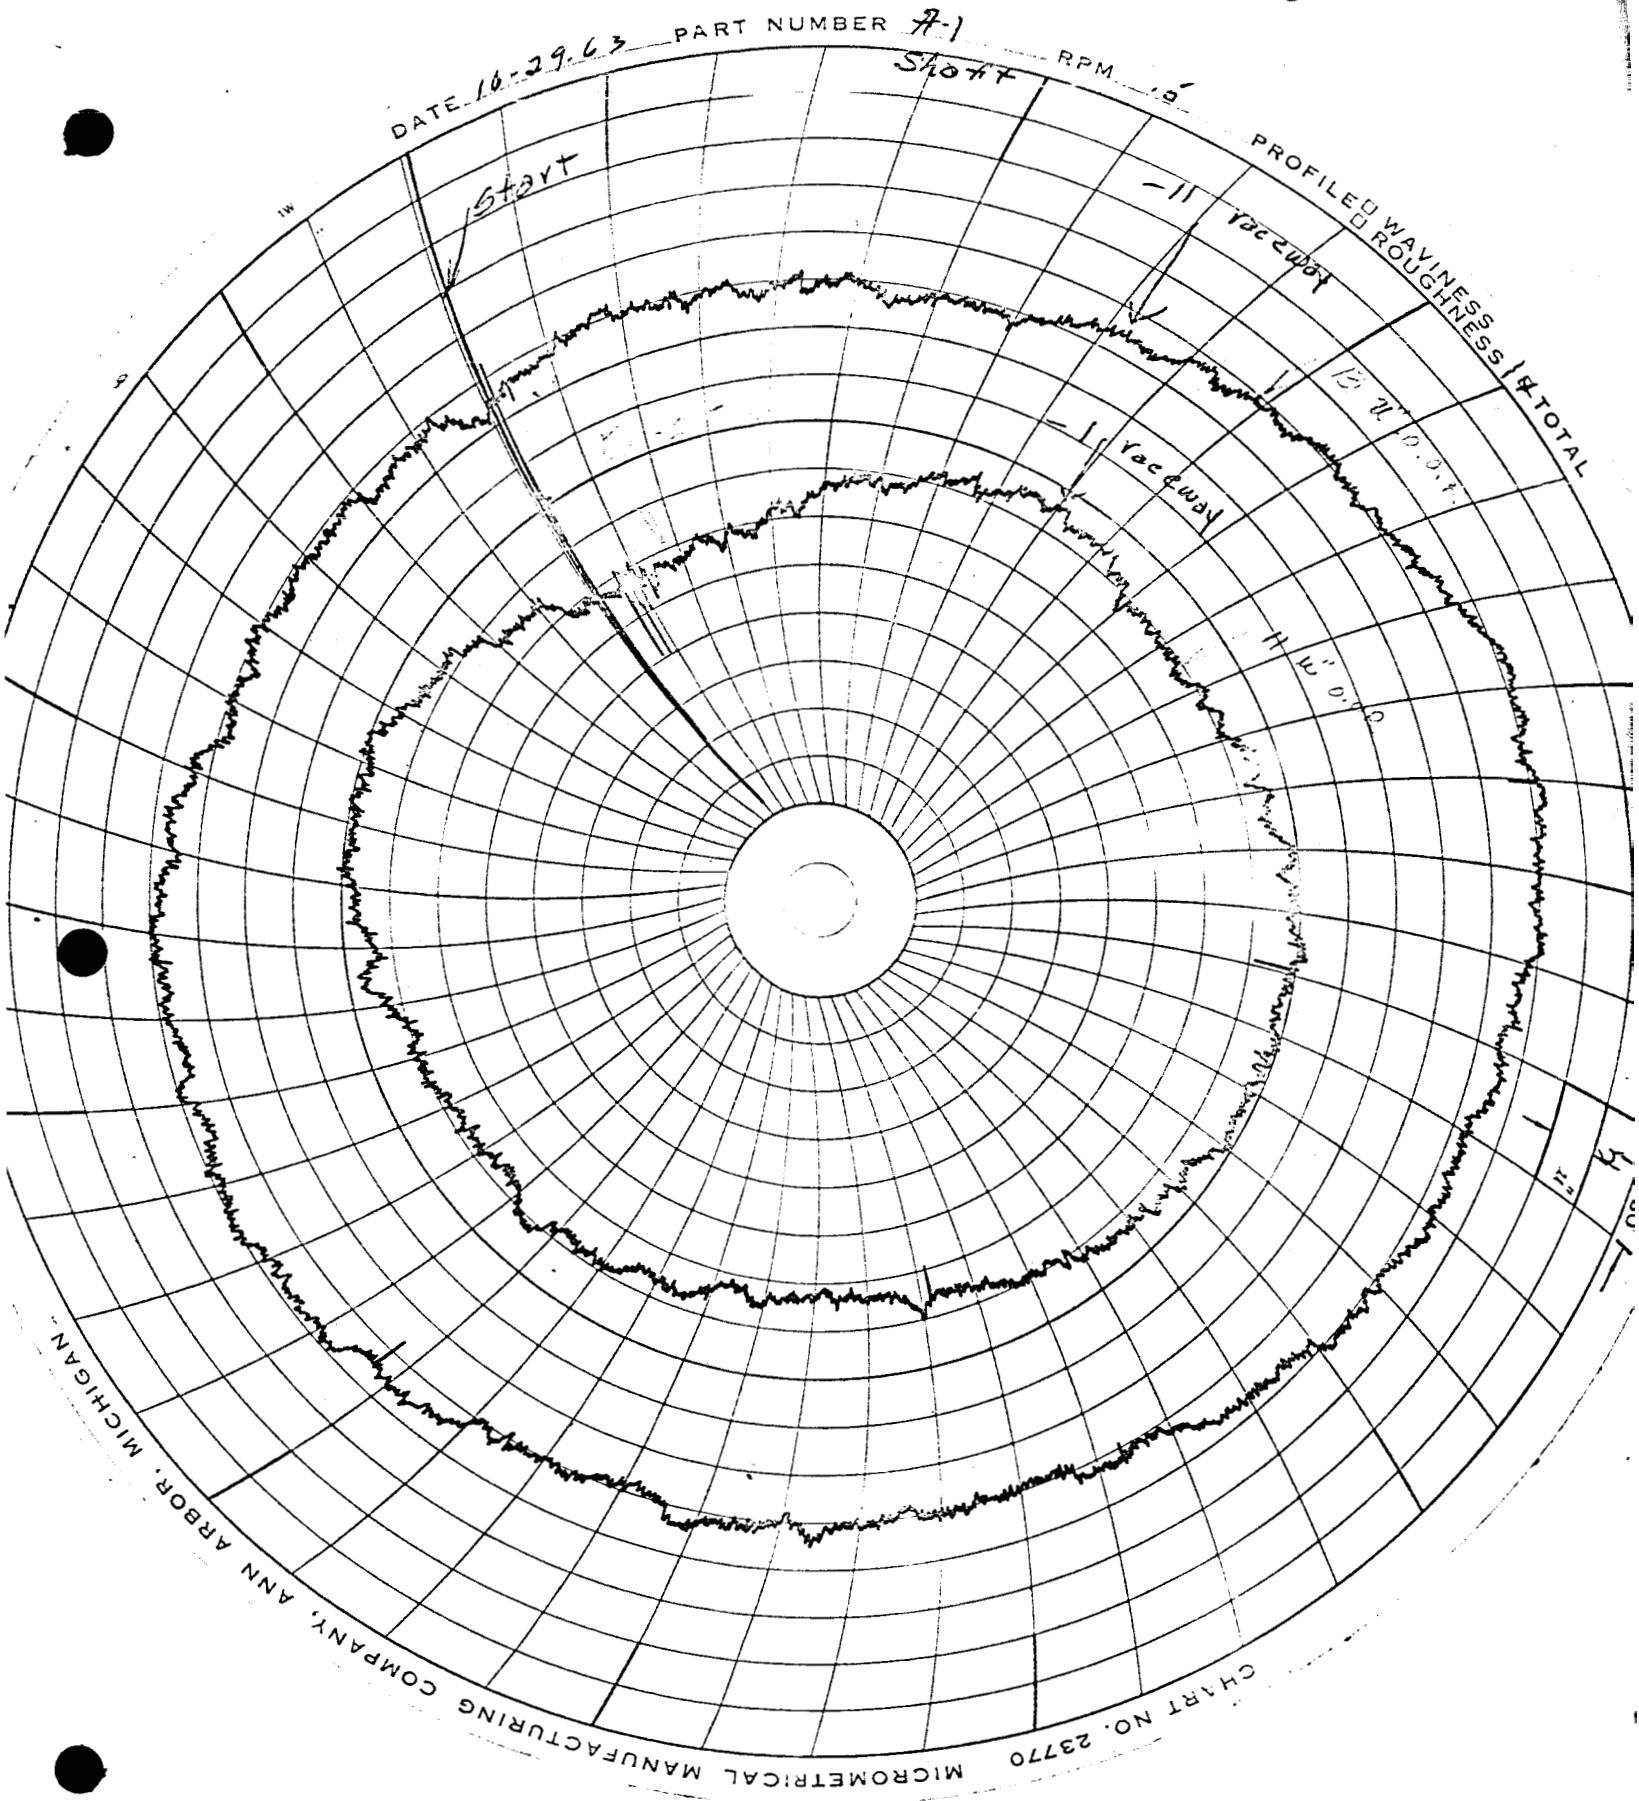
PROFICORDER TRACES OF INNER RACES OF LOT A BEARING NO. 1

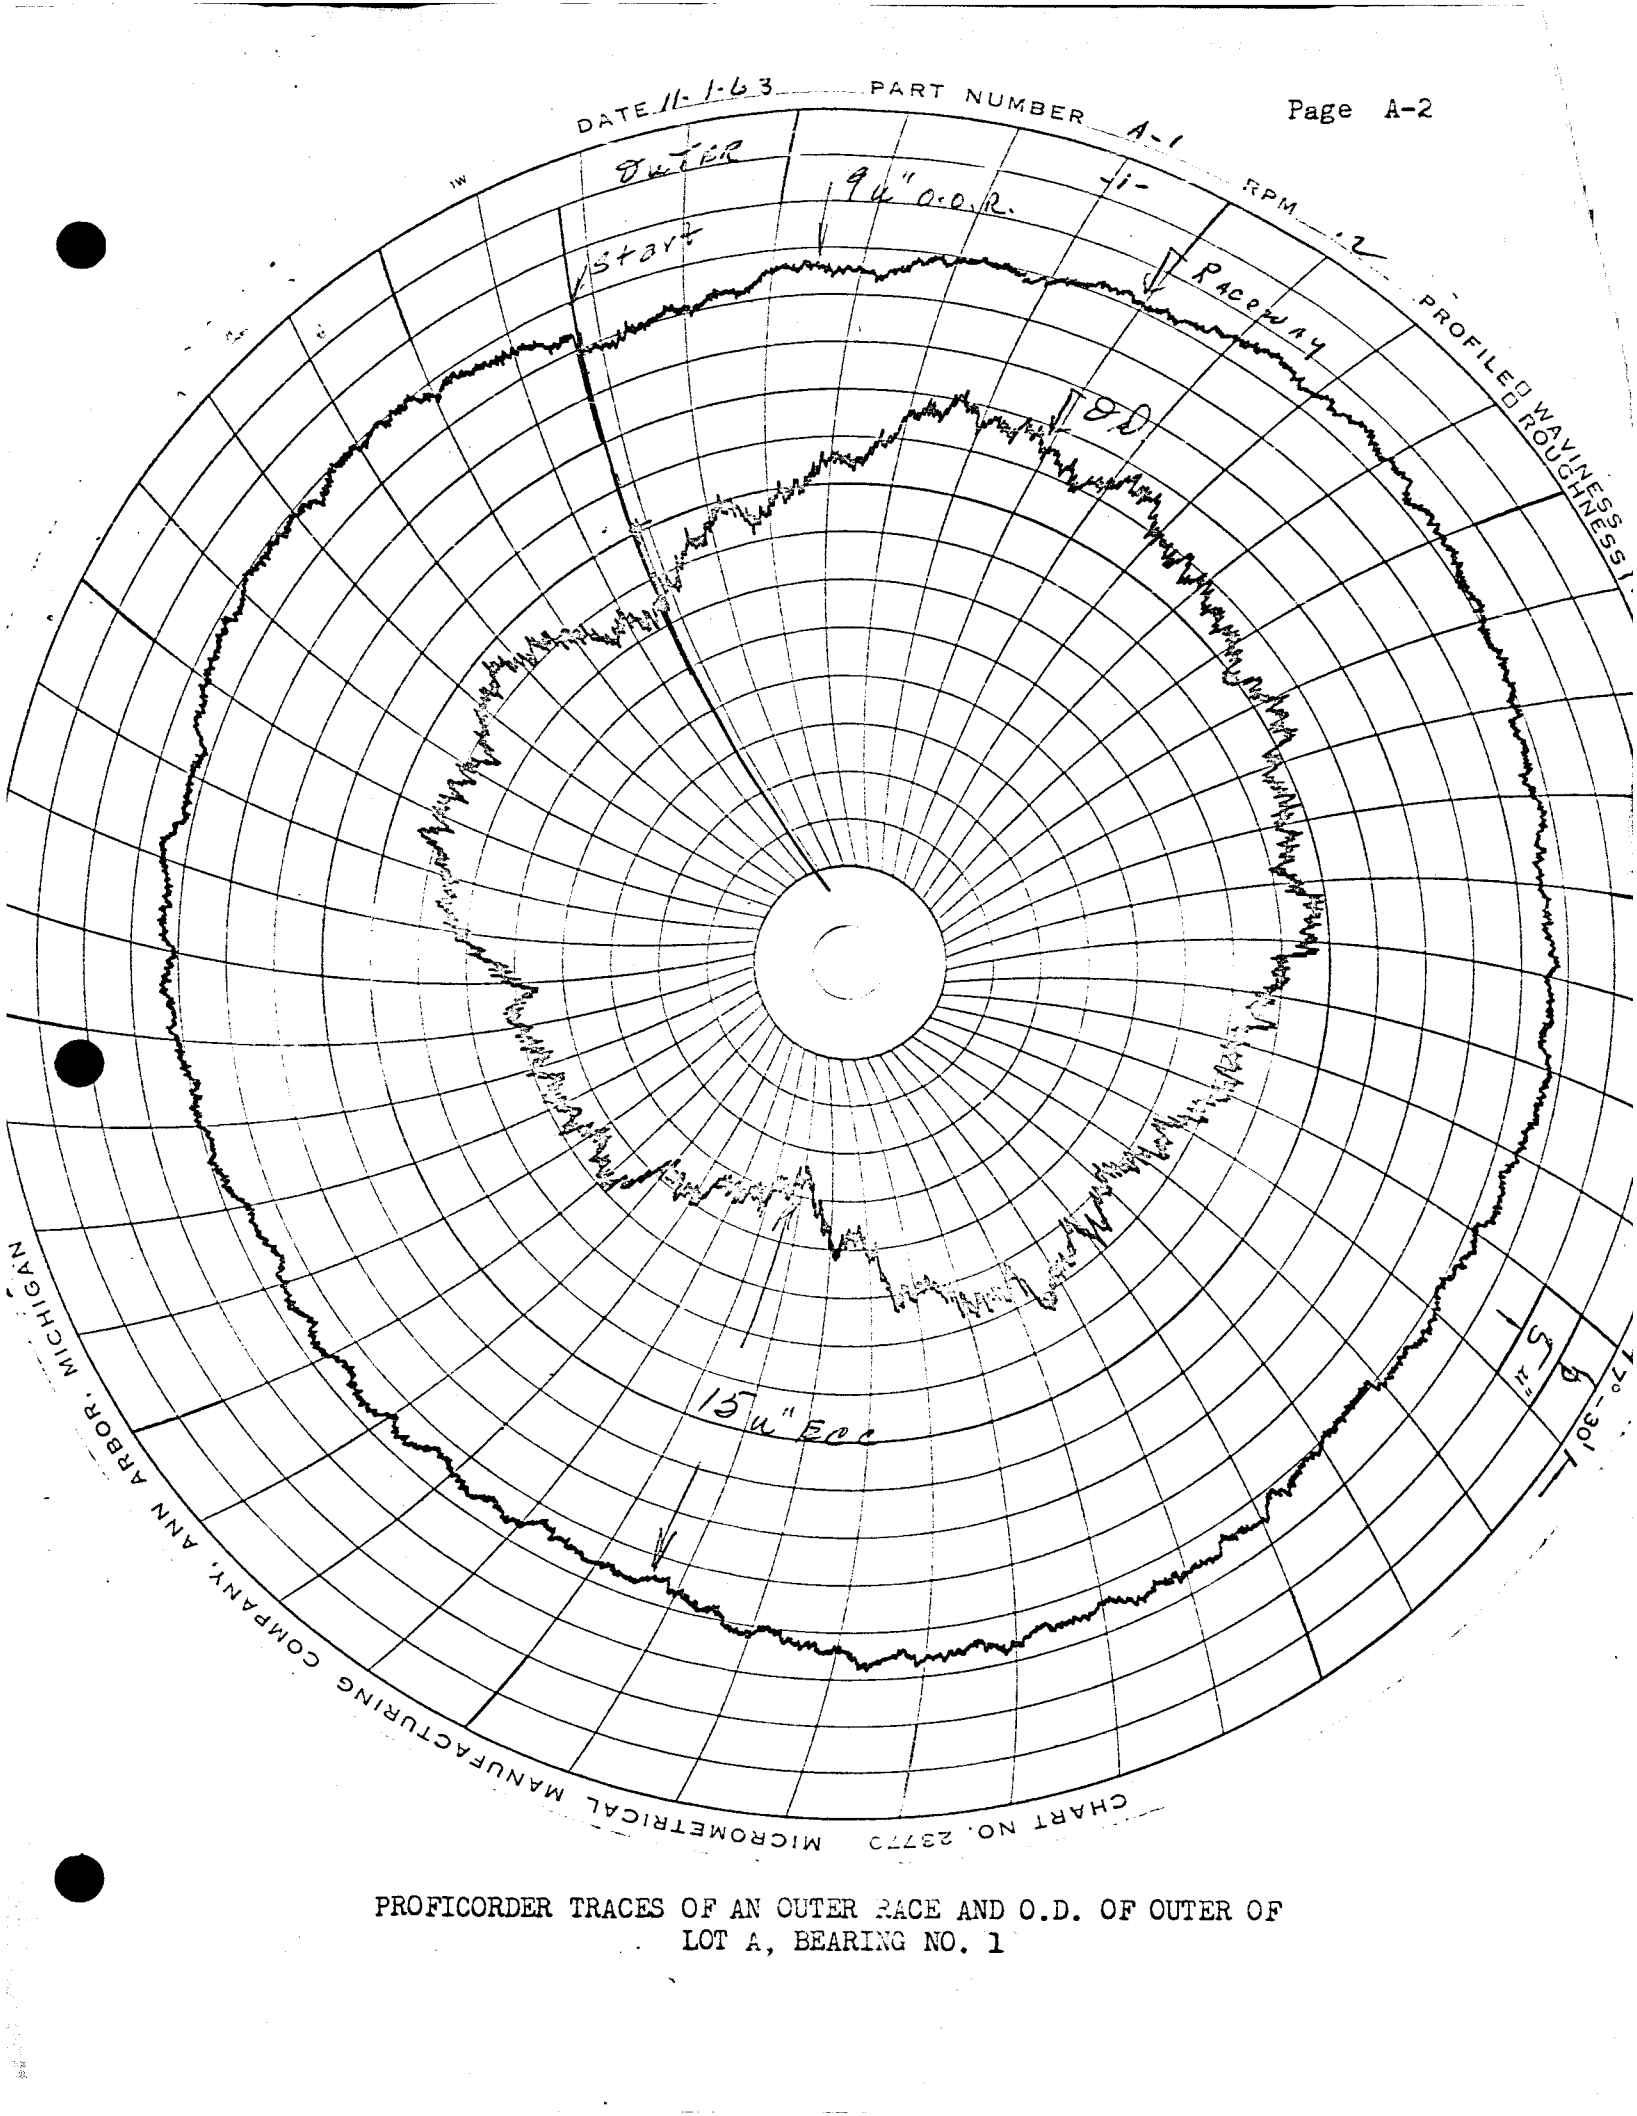
PROFICORDER TRACES OF AN OUTER RACE AND O.D. OF OUTER OF
LOT A, BEARING NO. 1

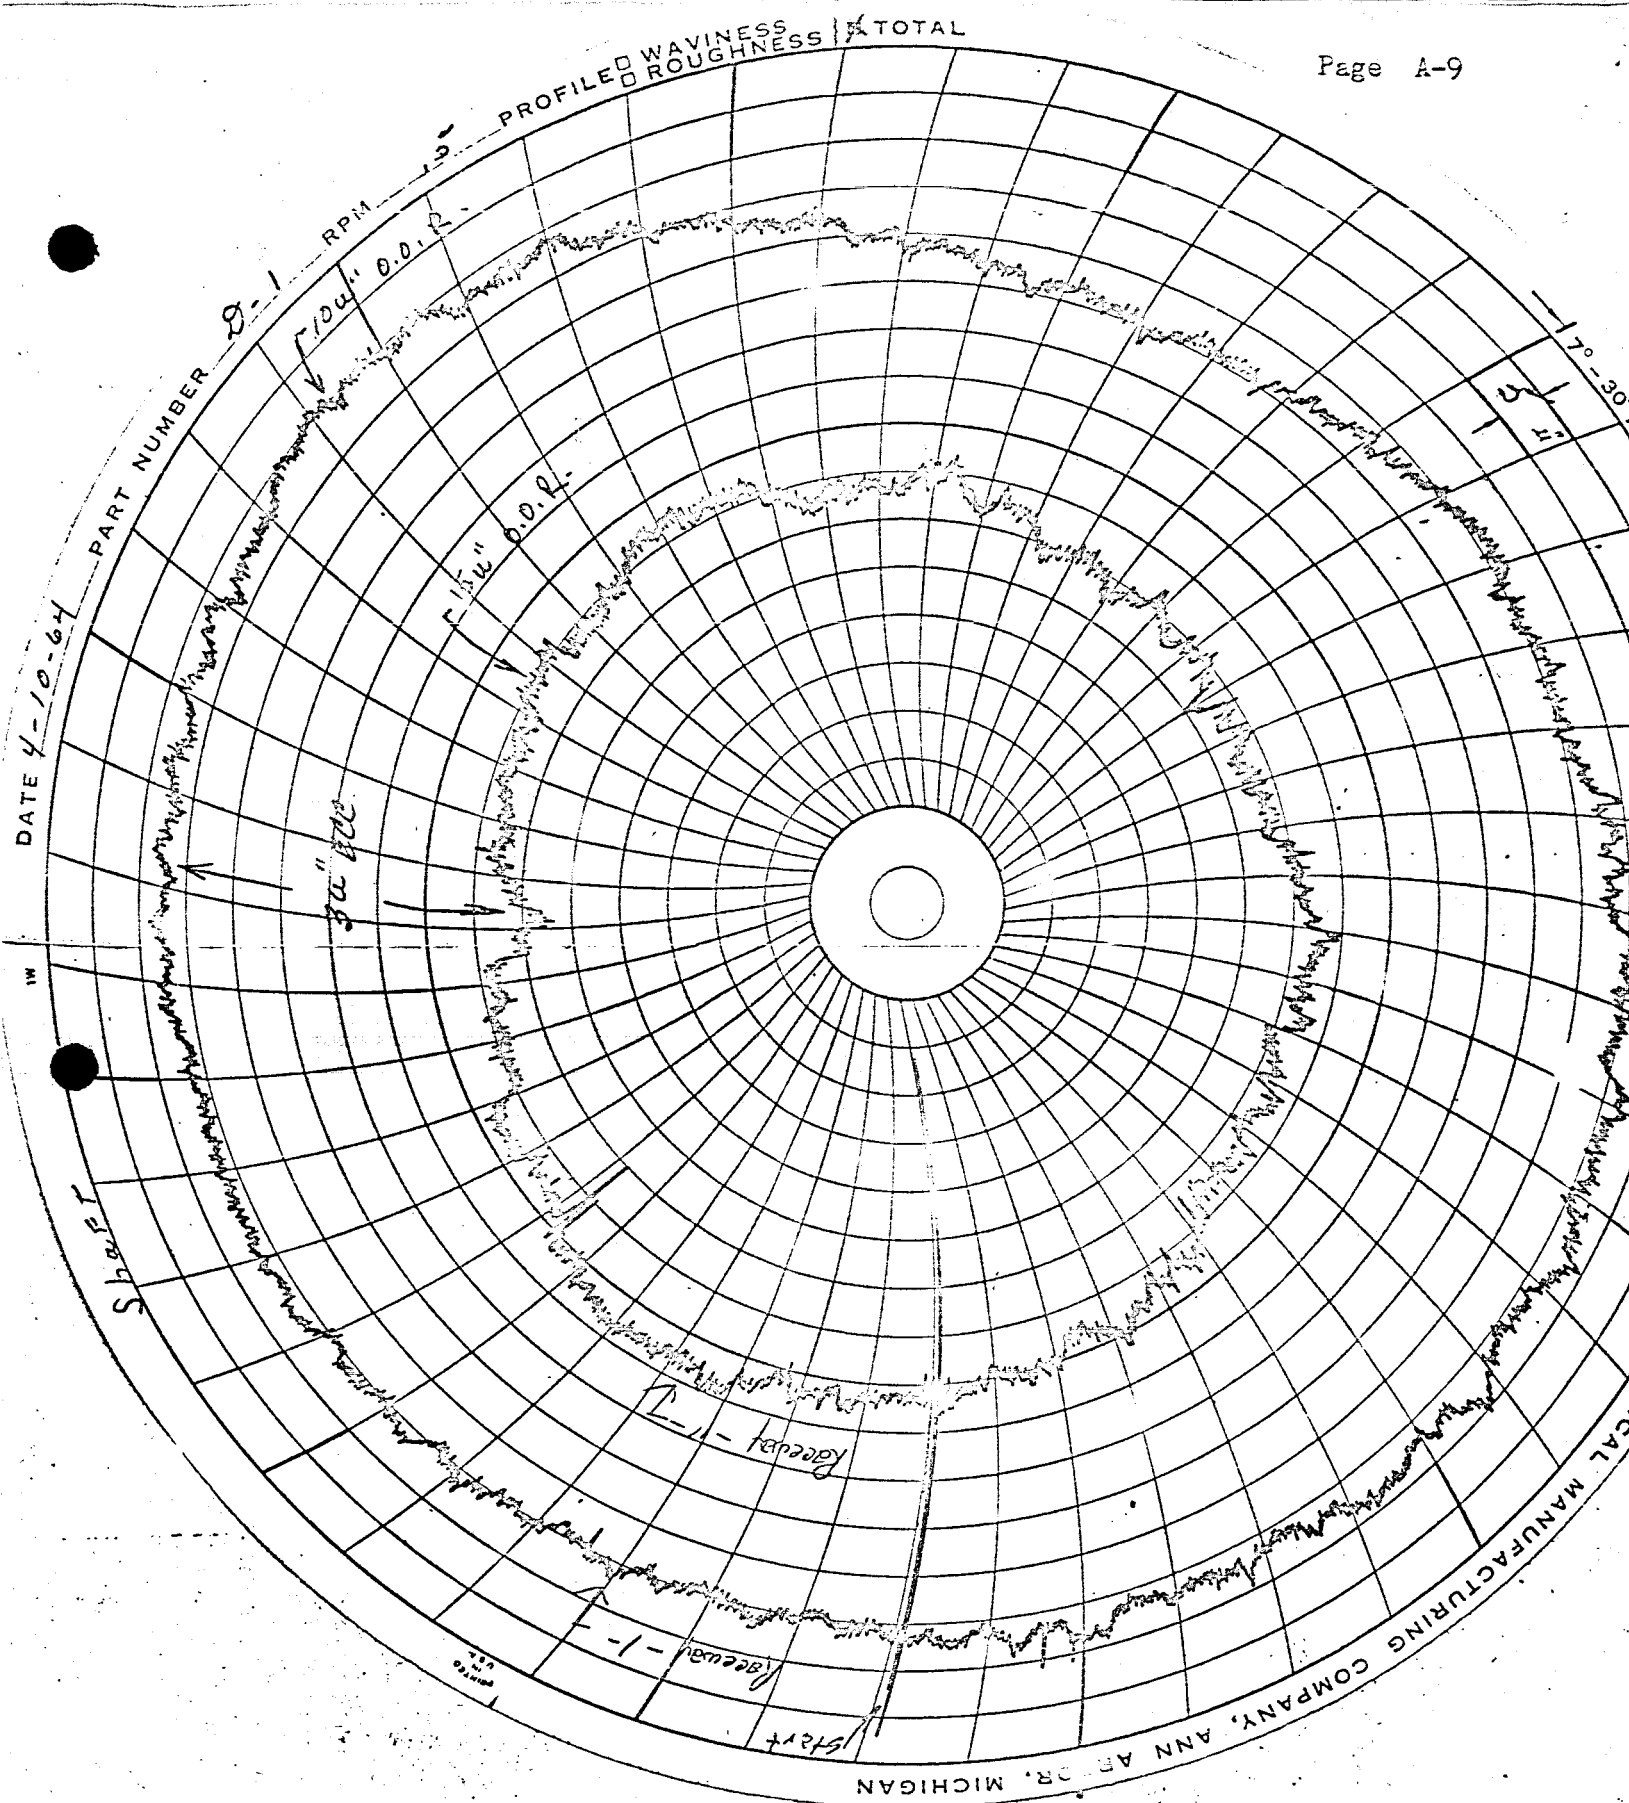
PROFICORDER RACES OF INNER RACES OF LOT D; BEARING NO. 1

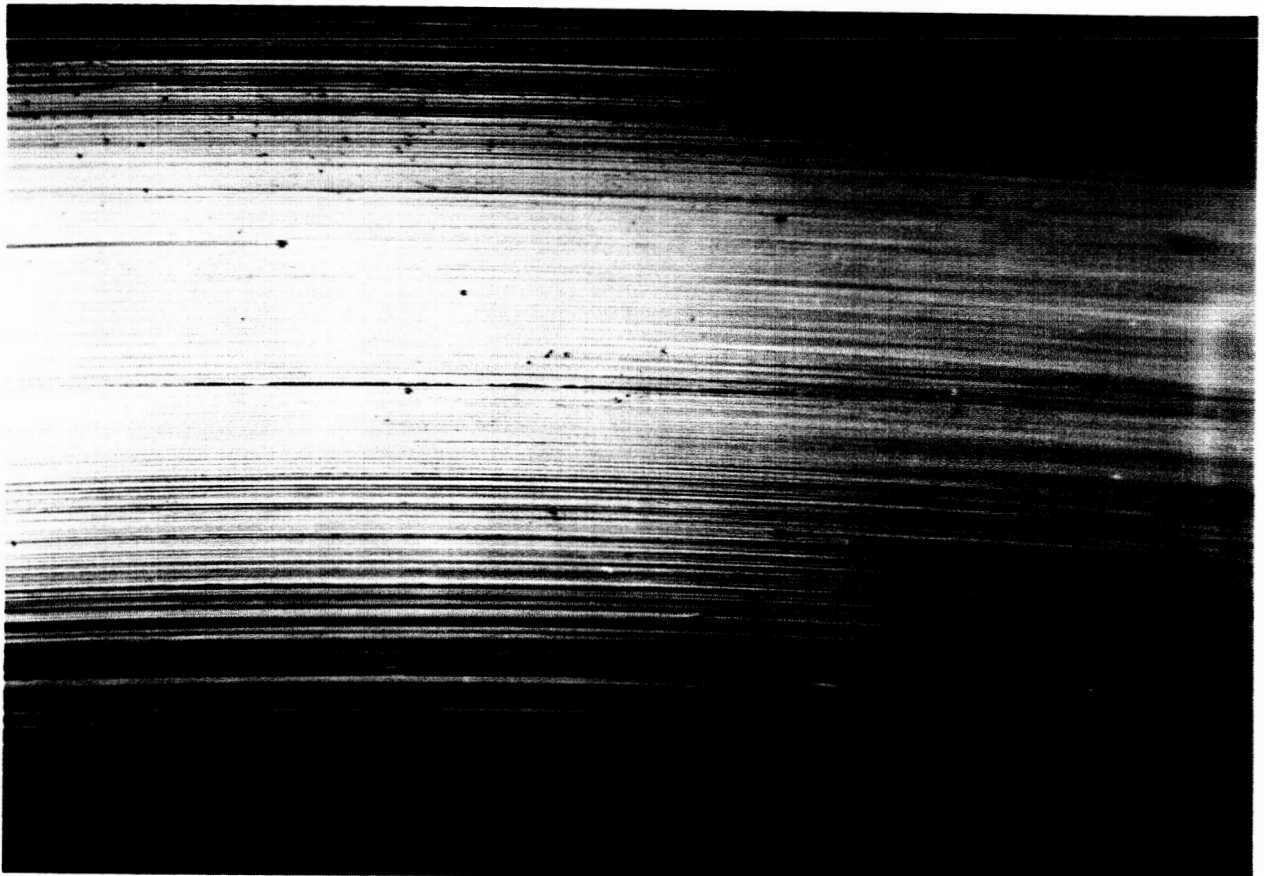
PHOTOGRAPH OF FINISH OF INNER RACE OF
LOT D, BEARING NO. 12 AT 250X MAGNIFICATION

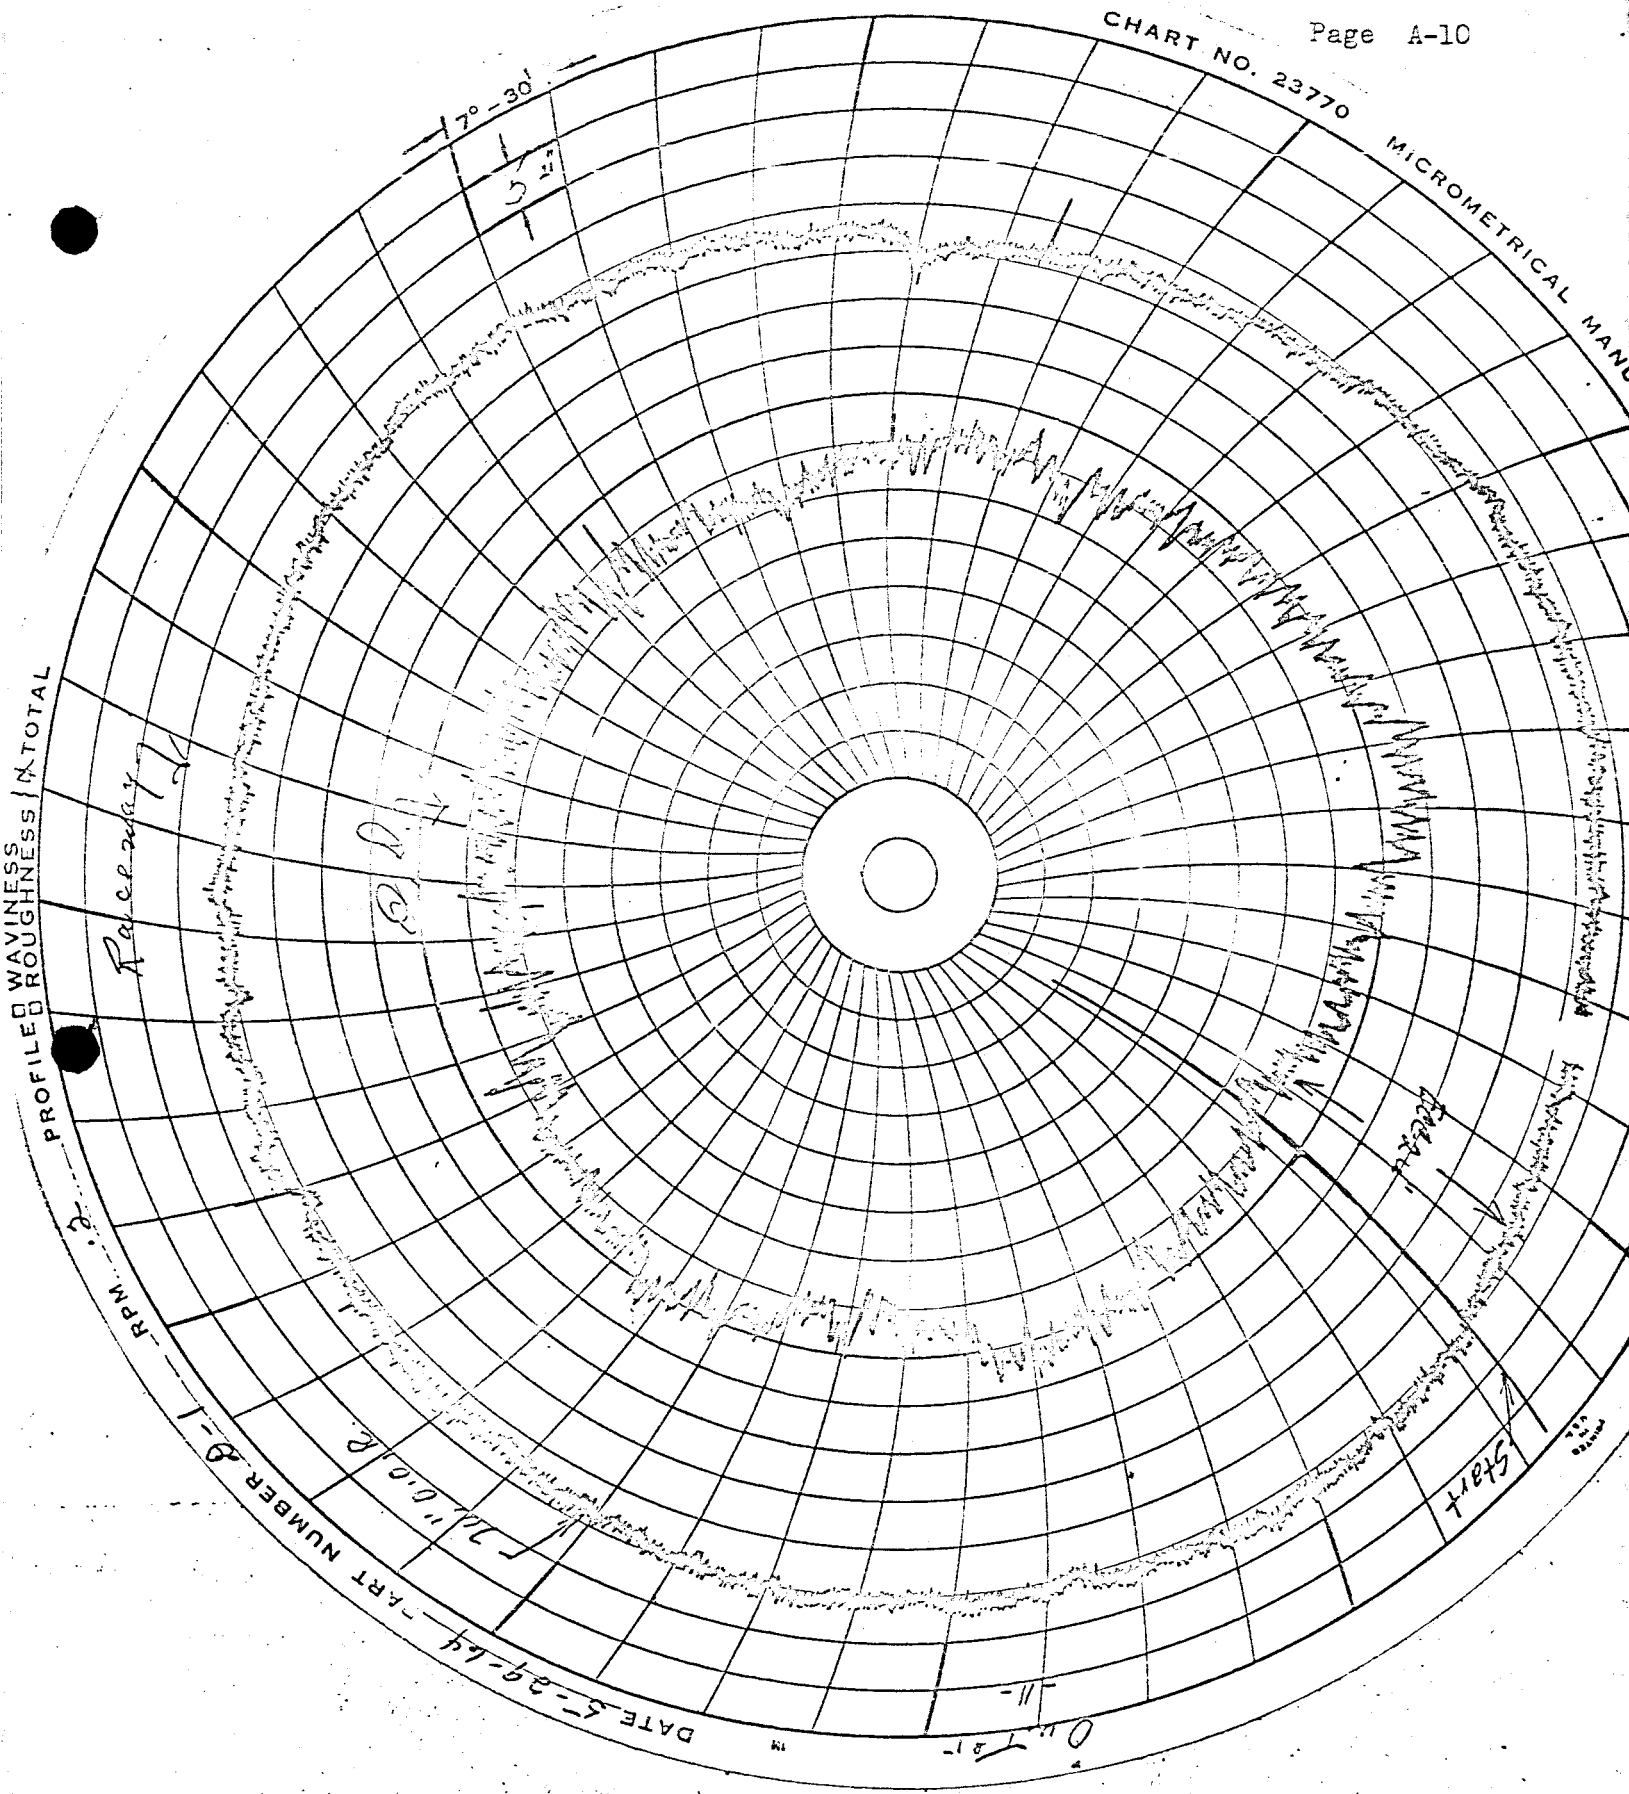
PROFICORDER TRACES OF AN OUTER RACE AND C.B. OF OUTER OF LOT D, BEARING NO. 1

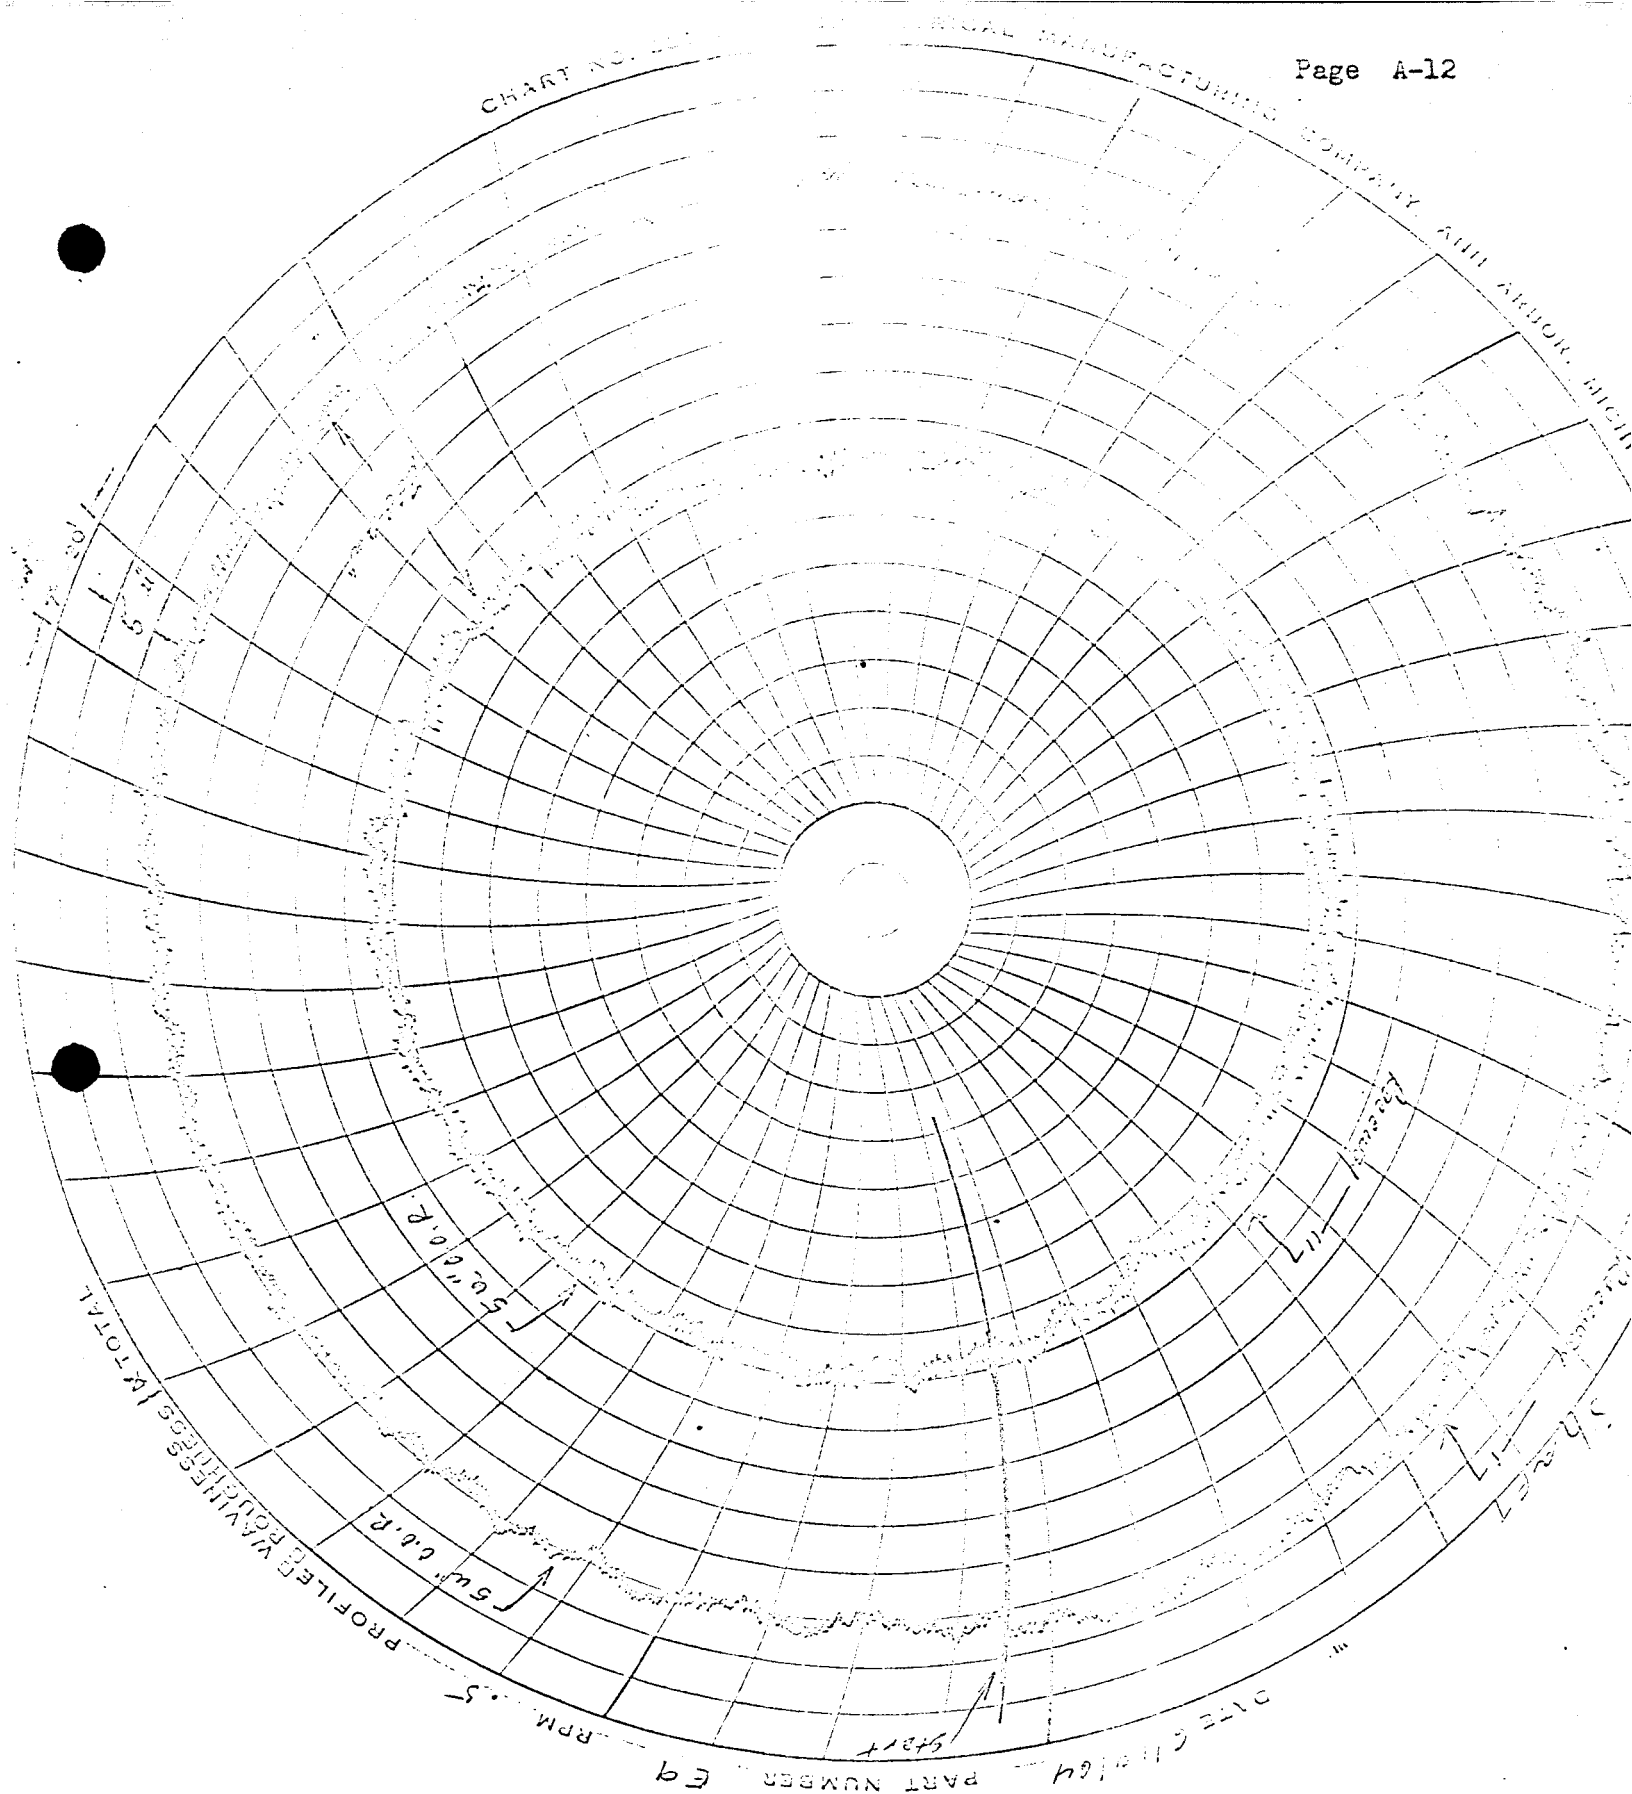
PROFICORDER TRACES OF INNER RACES OF LOT E, BEARING NO. 9
